Manhole Inspection Summary

Manhole # S17AA1030MH

Location Address: **2334 DRUID PARK DR**

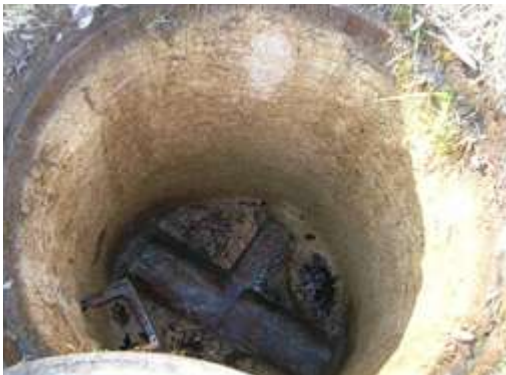
Defect

Frame Offset: **0** (in.) Condition: ☐ Sound ☐ Cracked ☒ **Leaks**

Infiltration: ☐ None ☒ **Joint** ☐ Cracks ☐ Mortar ☐ Roots ☒ **Wall**

Frame leaks. Adjustment infiltration

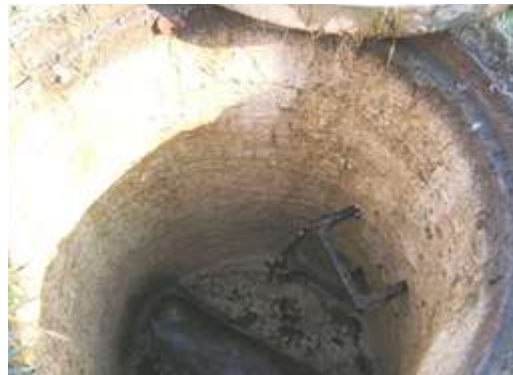
Defect

Frame leaks. Adjustment infiltration.

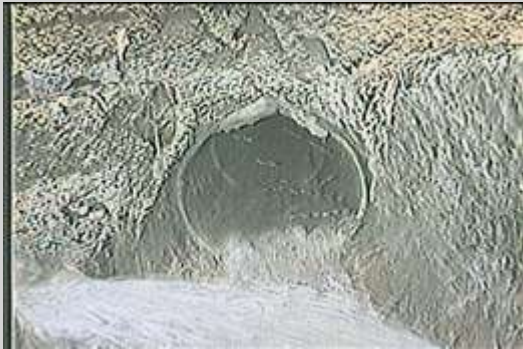
12 in. Circular Gravity Sewer Pipe Out @ 12 O'Clock

Pipe Material: **Unknown** ☒ Pipe Lined

Invert Depth: **7.53** (ft.) Flow Characteristics: **Fast**

Infiltration: **None** Pipe Seal Cond: **Unknown**

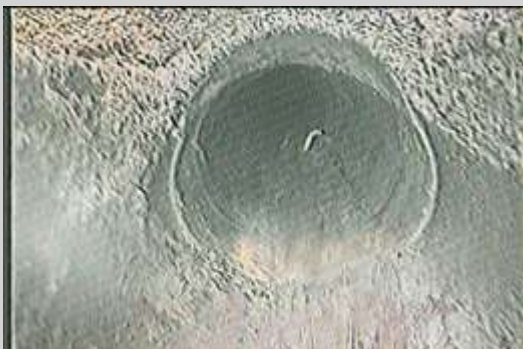
12 in. Circular Gravity Sewer Pipe In @ 6 O'Clock

Pipe Material: **Unknown** ☒ Pipe Lined

Invert Depth: **7.26** (ft.) Flow Characteristics: **Fast**

Infiltration: **None** Pipe Seal Cond: **Unknown**

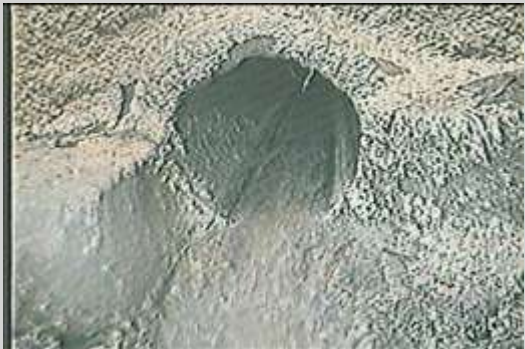
8 in. Circular Gravity Sewer
Pipe In @ 9 O'Clock

Pipe Material: **Unknown** ☐ Pipe Lined

Invert Depth: **6.72** (ft.) Flow Characteristics: **Fast**

Infiltration: **None** Pipe Seal Cond: **Unknown**
